# AVALANCHE HAZARD ASSESSMENT

# RICO-ARGENTINE MINE

# PROJECT SITE

AMEC ENVIRONMENT AND INFRASTRUCTURE INC.
PROJECT NUMBER: 52964AV
DECEMBER 3, 2013

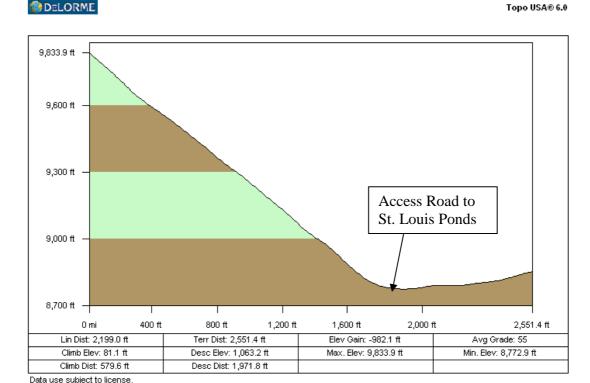
Figure 2. Profile of Path 3 "Sanchez" avalanche path. Note that the scale is vertically exaggerated.

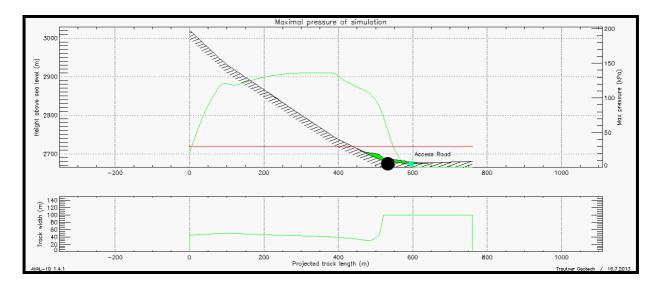
The calculated potential impact pressure at St. Lewis Road from the design avalanche for the Path 3 "Sanchez" Avalanche Path is approximately 72 kPa (1,504 lb/ft²; Figure 3). These pressures fall within the parameters for the Red Zone. The maximum calculated velocity for the design avalanche from Path 3 at St. Lewis Road is 17 meters per second (m/s; 38 miles per hour [mph]; Figure 4).

Figure 3. Topographic profile of the Path 3 avalanche path with modeled maximum impact pressure (shown in green) for a release with a 1.5 meter slab. The estimated impact pressure at the St. Lewis Road (black dot) is approximately 72 kPa  $(1,504 \text{ lb/ft}^2)$ . The red line indicates an impact pressure of 30 kPa on the right Y-axis.

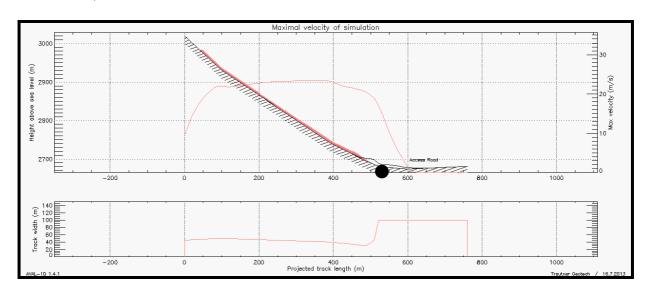
Figure 4. Topographic profile of the Path 3 avalanche path with modeled maximum velocity (in red) for a release with a 1.5 meter slab. Velocity is 17 m/s (38 mph) at the St. Lewis Road (black dot).

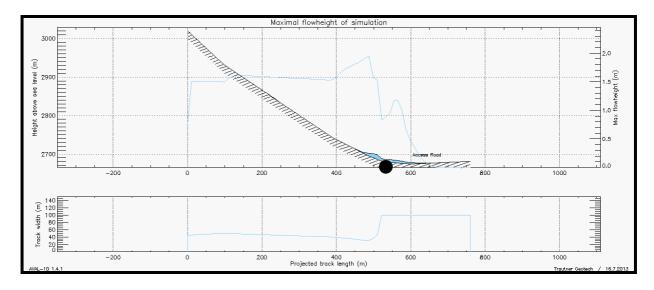
The modeled potential flow heights for Path 3 (Figure 5) indicated a maximum estimated flow height of approximately 0.83 meters (2.7 feet) at the St. Lewis Road. This depth represents the flowing height of avalanche debris. Actual snow depths could be much greater if debris hit an object and piled up.

Figure 5. Topographic profile of the Path 3 avalanche path with maximum flow height of snow (in blue) for a release with a 1.5 meter slab. Estimated snow height at the St. Lewis Road (black dot) is 0.83 m (2.7 feet).

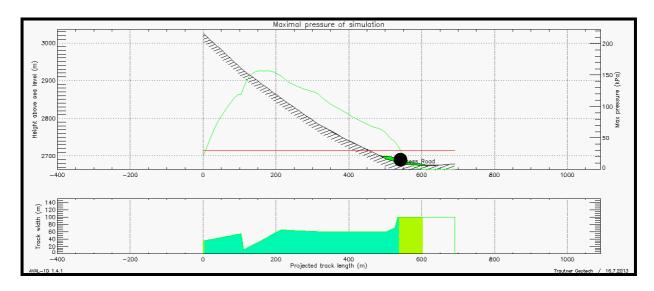
Figure 6. Topographic profile of the Path 1 avalanche path with modeled maximum impact pressure (in green) for a release with a 1.25 meter slab. The estimated impact pressure at the St. Lewis Road (black dot) is approximately  $38 \text{ kPa} (794 \text{ lb/ft}^2)$ . The red line indicates an impact pressure of 30 kPa on the right Y-axis.

The calculated potential impact pressures<sup>1</sup> from design avalanches with 1.5 meter thick slabs from the avalanche paths above the St Louis Ponds area ranges from approximately 38 kPa (794 lb/ft<sup>2</sup>) to 72 kPa (1,504 lb/ft<sup>2</sup>) at St. Lewis Road (Figures 3 and 6). These pressures fall within the parameters for the Red Zone. The estimated potential maximum flow height<sup>2</sup> of snow from avalanche debris at St. Lewis Road is approximately three (3) feet.

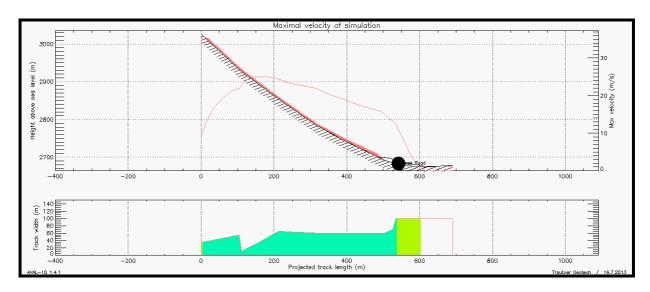
Figure 7. Topographic profile of the Path 1 avalanche path with modeled maximum velocity (in red) for a release with a 1.25 meter slab. Velocity is 12 m/s (28 mph) at the St. Lewis Road (black dot).

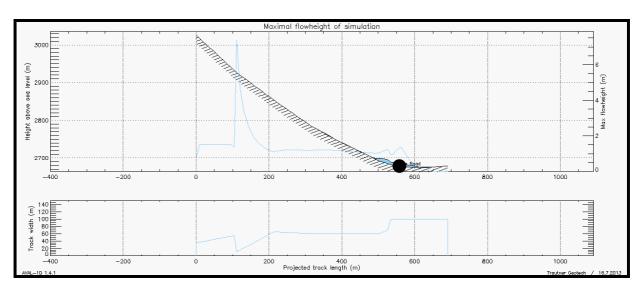
Figure 8. Topographic profile of the Path 1 avalanche path with modeled maximum flow height of snow (in blue) for a release with a 1.25 meter slab. Estimated snow height at the St. Lewis Road (black dot) is 0.94 m (3 feet).

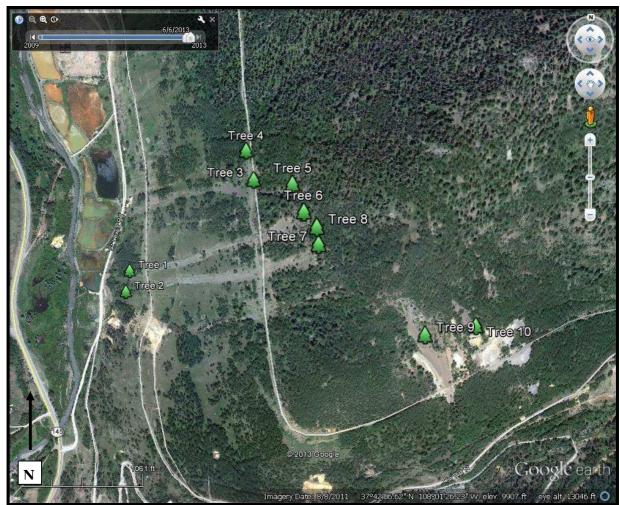
Ten trees were sampled in or adjacent to the avalanche paths near the site (Figure 9). The approximate age of each tree is shown in Table 1. Trees of similar diameters were noted in areas where samples were taken.

Figure 9. Locations of dated trees near the Rico-Argentine Mine. Numbers correspond to Table 1.

Based on the dendro-chronological techniques and modeling methods described above, the avalanche paths above the St. Louis Ponds area have an approximate return period of 25 years or less. The large avalanche paths along County Road N have an approximate return period of 50 to 75 years.

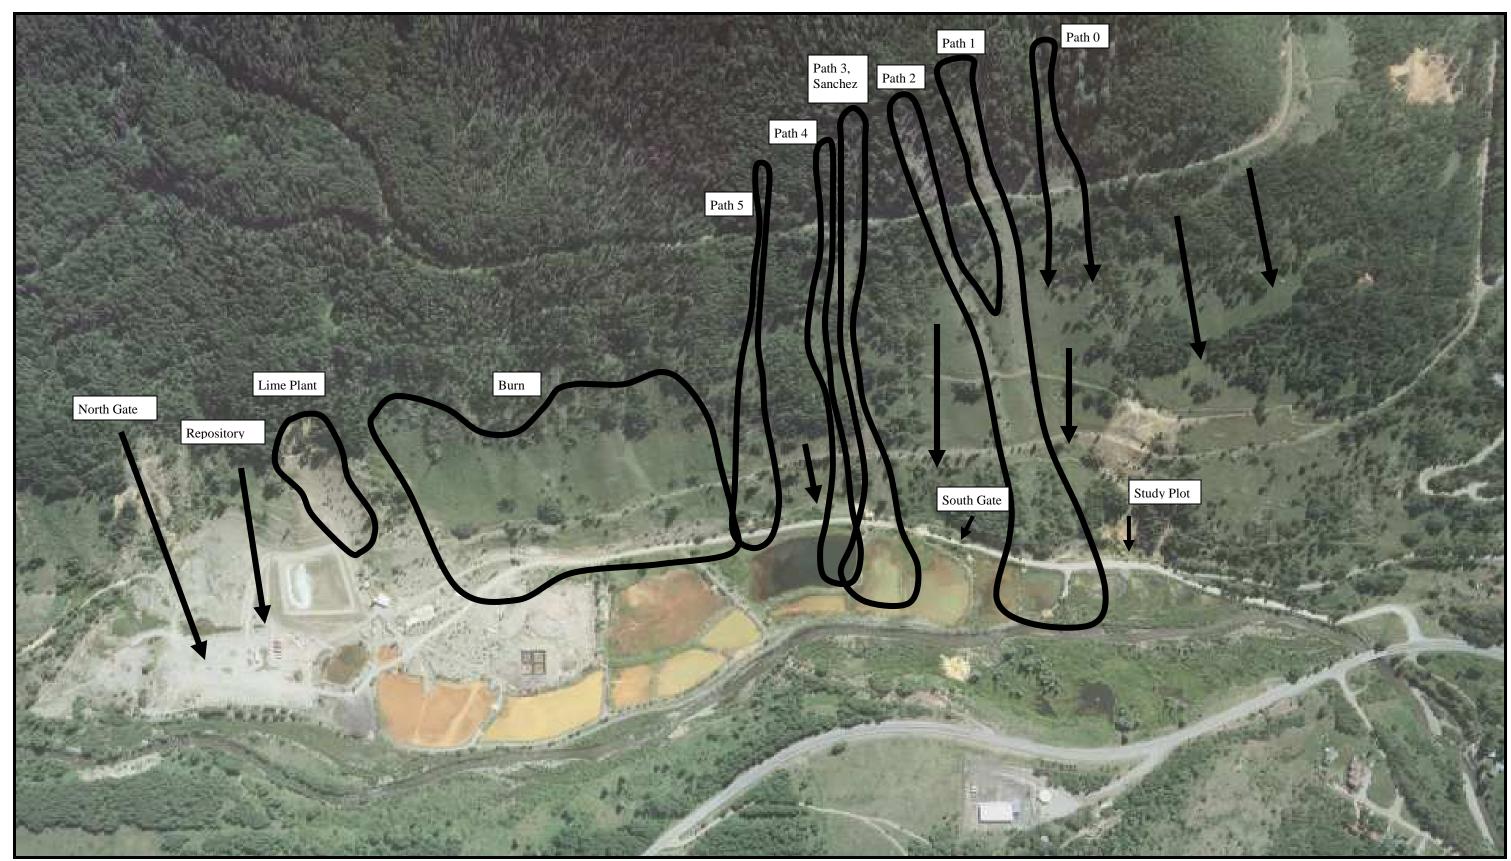
The local history of avalanche paths at the site are not documented, but Mr. Chris Sanchez of Anderson Engineering Company, Incorporated, who has worked in the site vicinity since 2005, was interviewed on the subject. Mr. Sanchez observed an avalanche in Path 3 (Plate 1) during the winter of 2009-2010 (date and time unknown) that ran over St. Lewis Road and deposited approximately five (5) feet of avalanche debris on the road. No other avalanches were observed by Mr. Sanchez during the time period of 2005-2012, but he mentioned that he did not specifically look for avalanche debris.

Path 3 did have an avalanche occurrence on January 30, 2013, that deposited avalanche debris within about 20 feet of St. Lewis Road. The storm that produced this avalanche had 2.55 inches of snow water equivalent, as measured at the study plot located along St. Lewis Road (Plate 1).

We consider that the area along the St Louis Ponds access road is in the Red or High Avalanche Hazard Zone. We consider the area along the access road to the Argentine Mill and the area surrounding the Argentine Mill to be within the Blue or Moderate Hazard zone. The locations of avalanche paths shown on Plates 1 and 2 are based on the history of the paths, size and damage to the trees above the site and the avalanche dynamics modeling we conducted. The estimated impact pressures are based on design avalanches which occur during extraordinary snowfall events and would produce avalanches capable of causing damage to any structure not protected by avalanche mitigation. These events would involve a large storm event coupled with a weak layer of snow on which the storm snow would fall. Normal snowfall amounts can produce avalanches on the subject property and caution should be taken when traveling on or near the slopes during snowfall events. We recommend monitoring of the snow conditions during winter months in the area near the St. Louis Ponds and the Argentine Mill access road to determine if personnel should be cautioned regarding the potential avalanche hazard.

Plate 1. Avalanche Path Map, Rico-Argentine Mine, St. Louis Ponds Area. Black outlines indicate known avalanche paths. Black arrows indicate potential avalanche paths.

The estimated impact pressures and snow height amounts that were calculated for the avalanche areas in the vicinity of the St Louis Ponds are within magnitudes that can be mitigated if desired. There are many types of mitigation that would be reasonable at the subject site. A site specific mitigation design is beyond the scope of this report. If site specific mitigation is desired please contact us.

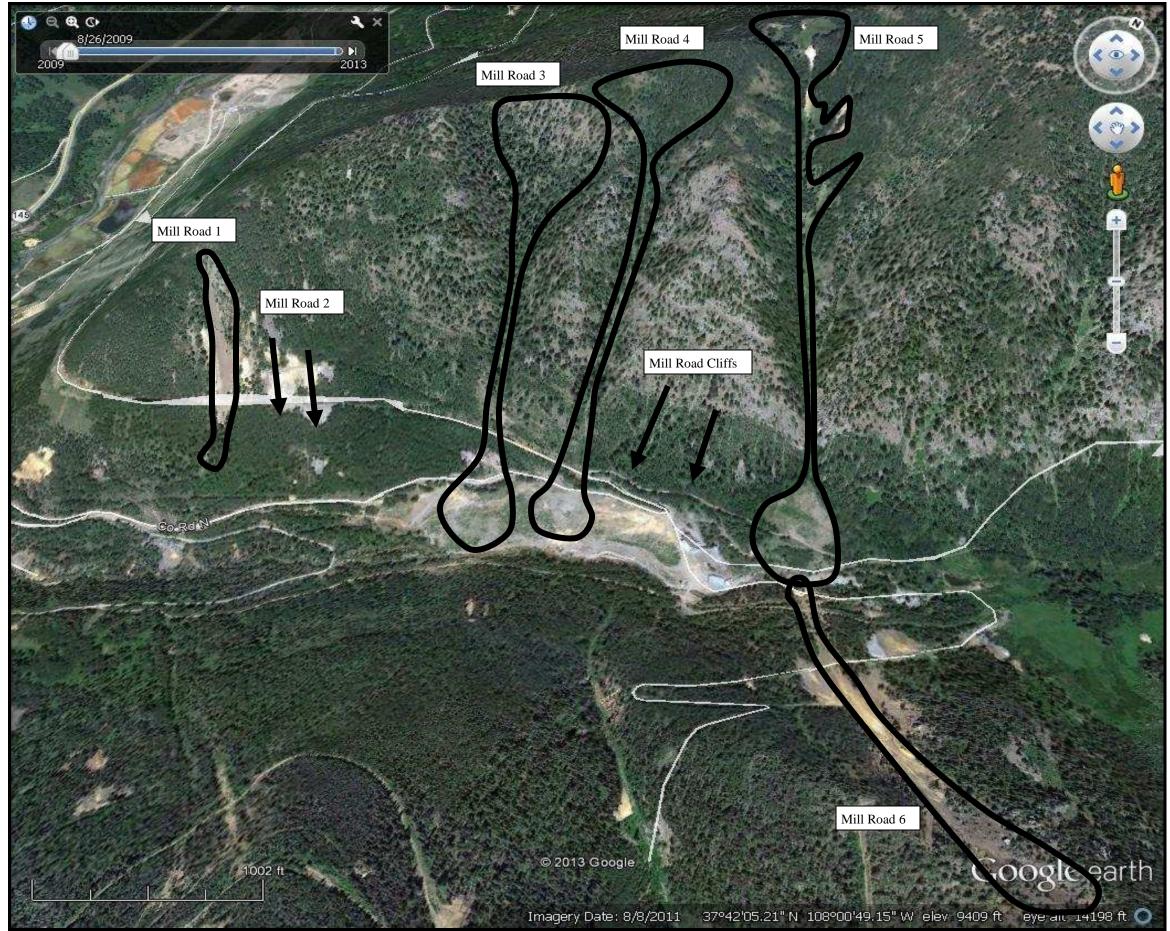
The area along the Mill road for access to the Argentine Mill is considered to be in the Blue or Moderate Avalanche Hazard Zone based on the same criteria as above. The avalanche paths can be considered to have a relatively low probability of occurrence with a low to moderate hazard. The avalanche paths Mill Road 1 through Mill Road 5 do not show any indication that they have reached the access road to the Argentine Mill within approximately the last 50 years. While we consider the avalanche hazard to be relatively low along the access road, a design avalanche event could deposit significant amounts of snow on the access road and pose a potential danger to anyone travelling the road during a heavy storm period.

Mill Road Paths 5 and 6 are located east of the Argentine Mill, but could affect nearby operations and access to nearby portals. Mill Road 6 had two avalanche events that were recorded during the winter of 2012-2013. One of these events deposited avalanche debris into Silver Creek to a depth of approximately two (2) feet.

Plate 2. Avalanche Path Map, Argentine Mill and access road.
